STUDY OF SPATIAL AND TEMPORAL VARIATIONS OF THE BUKTYRMA RIVER BANK EROSION

This study addressed the causes, mechanism and different forms of bank erosion of the Buktyrma River near to human settlements; their dependence on the morphology of banks, connection with river channel deformations is clearly shown. For this purpose, multi-temporal space images and cartographic materials were used. The calculation of the horizontal deformations of the riverbed was performed by GIS. When modeling channel processes, the following data was used: space images RapidEye, Landsat and Sentinel -2 for the period from 1975 to 2017, topographic maps 1960-1980, data of geodetic surveys 1965-2010, digital elevation model SRTM 2000, field observations at coastal destruction sites for 2011-2017, geological map of 1979 and geomorphological map of 2010. Based on SRTM digital elevation model drawn map showing the river systems of the structure, characteristics and hypsometric Buktyrma catchment area of the river. The article shows examples of identifying scouring river banks by space images near 5 settlements - Kaiyndy, Shyngystai, Bykovo, Parygino and Turgusun. A hydromorphological analysis of the channel

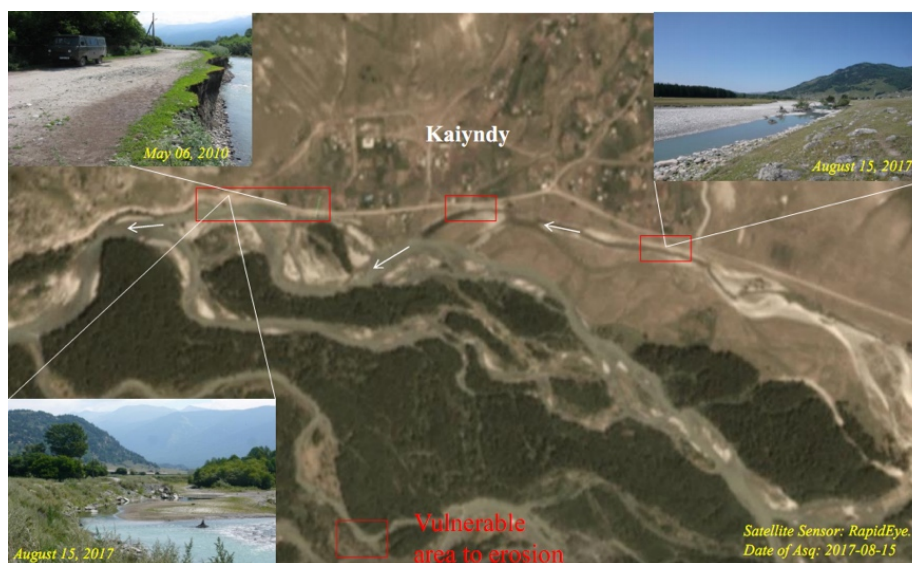
Figure 2. Bank erosion within village Kaiyndy

The annual average erosion during intensification of the erosion process in high-water years of 1966, 1969, 1973, 1980 achieved 6 m a year. In the period of 2005-2007 the annual average erosion constituted 1,91-2,15 m a year, which is below that of the previous period, whereas in the period of 2011-2017 overall erosion in the western outskirts of the village constituted 0,38-0,39 m a year, which means that another period of the erosion process decrease is likely to start. However, the situation in the western outskirts of the village reached a critical level by May 2010.

There was a 9 m distance between the nearest house and the bench crest, part of the road was destroyed. In spring 2010 measures were taken by state bodies before floods to reinforce the cliff. An earth embankment was erected in the western outskirts of the village, made of coarse-grained material of rocks with the ledge up to 6 m height, up to 4 m width and 1 km length.

The shoreline in the eastern outskirts of the village remained unchanged, where maximum erosion level in 2011-2017 constituted 0,65 m. The erosion process in this part is inactive, there is no direct threat to residential dwellings, road, which are 25-30 m from the cliff. The branch of the Buktyrma river is almost dry owing to the construction of another facility – a protective dam, blocking the water flow and directing main volumes of water to the own channel of the Buktyrma river (Figure 2).

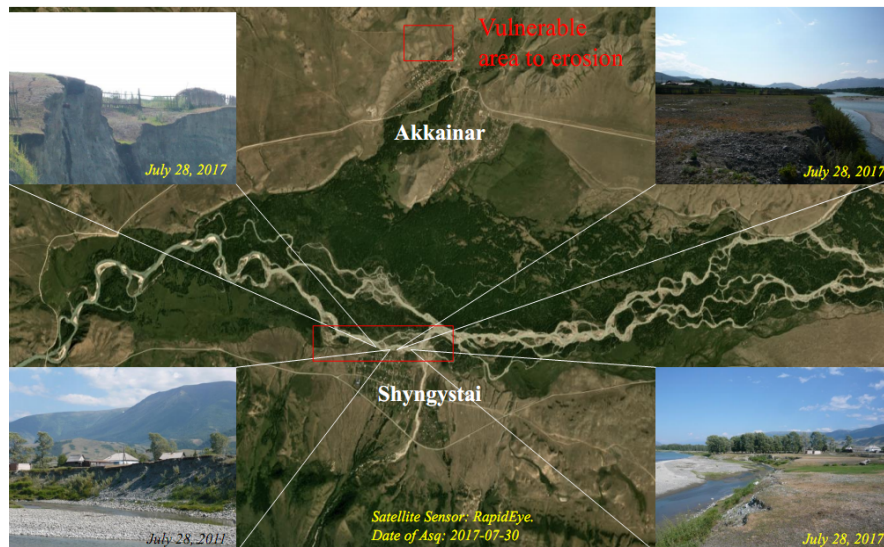
Figure 3. Bank erosion within village Shyngystai

Bank erosion area in the vicinity of village Shyngystai. The erosion process is weaker in the village of Shyngystai than in Bykovo and Parygino sites, which is probably due to the remoteness of this river sector from the mouth of the river Buktyrma and water flowing closer to the right bank of the current valley. However, there is widespread development of the erosion process along the shore. The cliff extends to about 1,5 km. The northwestern part of the village is destroyed intensively most of all. The maximum erosion rate of the site constituted 12,3 m in 2011-2017.

The intensification of the erosion process, when greatest erosion can be observed, occurs during flood periods, when it is time of flood flows of the Buktyrma river, therefore, highest river levels, which is explained by the year rainfall of the cold season. According to previous studies (1983-1984) in the eastern part of the post the creek moved closer to the

right bank of the current valley and the erosion of the cliff is eased a bit, however the energy of the water flow within the site is so high that the erosion process does not stop even in low-water seasons, it just decreases. The erosion of the cliff poses a threat to residences and farm structures, lands of the village (Figure 3).

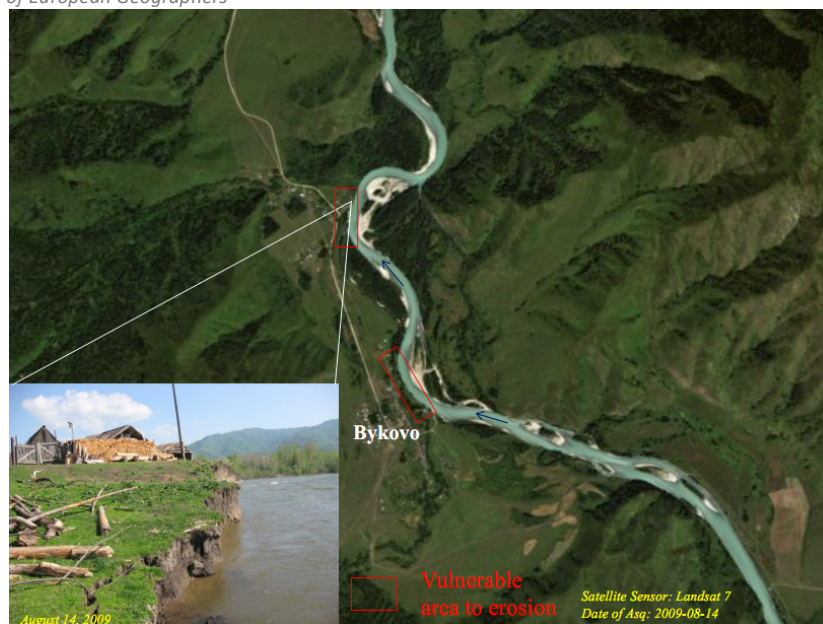
Figure 4. Bank erosion within village Bykovo

The erosion of the left bank of the Buktyrma river in the north-eastern and south-eastern parts of the village annually until 2010 constituted from 1,5 to 2,5 m with the overall length of the eroded bank 2,0 km. In spring 2010 in the north-eastern part of the village was small erosion (0,5 and 0,8 m) since protective measures were implemented before the start of the flood period. An embankment was erected, made of coarse-grained material of rocks, with the ledge up to about 500 m length, up to 4,5 m width and with erosion-preventive embankments deep into the river to reduce the speed of the current so that the destructive impact of the great water flow could be minimized.

Therefore, the threat to residencies and farm structures passed for some time, however the erosion process can be intensified above the protective embankment due to the redistribution of the water flow from the principal channel to left bank streams, especially during flood periods. The maximum erosion rate of the site in the south-eastern part of the village 9 m in 2011-2017. Residencies and farm structures are still under the threat of collapse (Figure 4).
